HISTORIC RESOURCES INVENTORY FORM

- 1. BUILDING NAME: Common: Davison Art Center Historic: Richard Alsop IV House
- 2. TOWN/CITY: Middletown VILLAGE: _____ COUNTY: Middlesex
- 3. STREET & NUMBER (and/or location): 301 High Street
- 4. OWNER(S): Wesleyan University PUBLIC PRIVATE
- 5. USE: Present: Art Center Historic: Residence
- 6. ACCESSIBILITY TO PUBLIC: Exterior visible from public road: yes no
Interior accessible: yes, explain galleries; restored rooms open no

Richard Alsop IV House
301 High St., Middletown, Ct. 06457

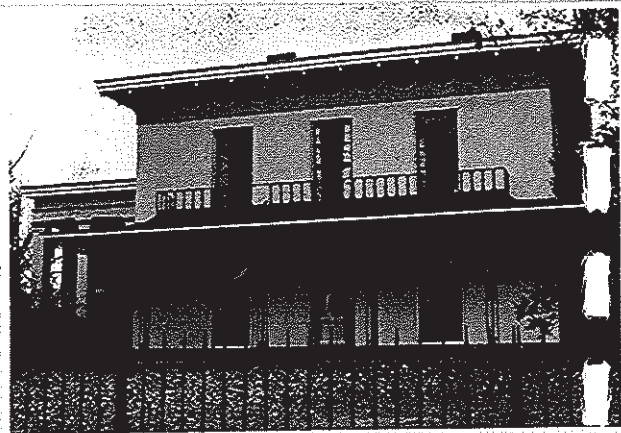
PHOTOGRAPH

This house is significant architecturally for its transitional Greek-Tuscan Italianate appearance. The cubical, two-story, central block with overhanging eaves is flanked by colonnaded one-and-a-half story wings. A swag and tassel design decorates the frieze of the central block, which also displays a veranda supported by delicate ironwork and surmounted by an intricate balustrade.

photographer: John E. Reynolds
 date: 11/77 view: east
 negative on file: Roll 2, #20
