STATE OF CONNECTICUT  
CONNECTICUT HISTORICAL COMMISSION  
9 South Prospect Street, Hartford, Connecticut 06106  
203) 566-3005  
HISTORIC RESOURCES INVENTORY FORM  
For Buildings and Structures

1. BUILDING NAME: Common: Caulkins Garage Historic: same  
 2. TOWN/CITY: Middletown VILLAGE: \_\_\_\_\_ COUNTY: Middlesex  
 3. STREET & NUMBER (and/or location): 489 Main Street  
 OWNER(S): F.L. Caulkins Auto Company PUBLIC  PRIVATE   
 5. USE: Present: Commercial Historic: same  
 ACCESSIBILITY TO PUBLIC: Exterior visible from public road:  yes  no  
 Interior accessible:  yes, explain commercial use  no

Caulkins Garage  
489-493 Main Street, Middletown, CT 06457

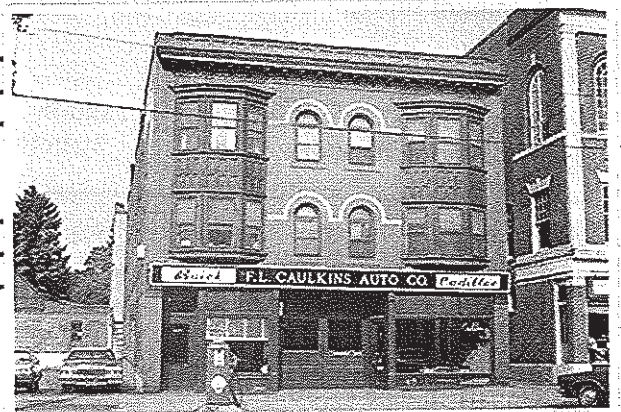
photographer: Elizabeth Loomis  
date: 5/78 view: east  
negative on file: Roll 25, #33

The glazed red brick facade of this structure contains all of its original crisp details and clear elements. Two green two-story bays on either side of the second and third stories are separated by two pairs of rounded arched windows which are outlined by yellow brick belt courses. The facade is surmounted by a heavy bracketed cornice capped by panels. The original street level store front contains large windows, four plain pilasters, and brown-stone thresholds.
