HISTORIC RESOURCES INVENTORY FORM  
For Buildings and Structures

- 1. BUILDING NAME: Common: \_\_\_\_\_ Historic: Seward-Wilcox House
- 2. TOWN/CITY: Middletown VILLAGE: \_\_\_\_\_ COUNTY: Middlesex
- 3. STREET & NUMBER (and/or location): 11 Maple Shade Road
- 4. OWNER(S): Thomas E. Wilcox PUBLIC  PRIVATE
- 5. USE: Present: Residence Historic: same
- 6. ACCESSIBILITY TO PUBLIC: Exterior visible from public road:  yes  no  
Interior accessible:  yes, explain \_\_\_\_\_ with permission  no

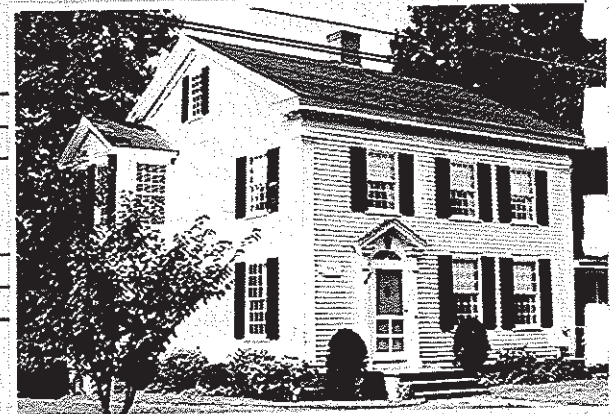
photographer: Elizabeth Loomis  
date: 10/78 view: east  
negative on file: Roll 37, #1A-2

The Seward-Wilcox house is a fine example of a popular house type of the Federal period in Middletown, displaying a three-bay-wide facade with the ridge of the roof to the street. Trim corner pilasters, with recessed center panels and capitals, support the entablature. Moldings and mutules decorate the cornice. The door, crowned with a pediment that is probably an addition, is framed by pilasters and a fanlight. Original clapboarding and window caps contribute to the well-preserved appearance of the house.
