HISTORIC RESOURCES INVENTORY FORM  
For Buildings and Structures

- 1. BUILDING NAME: Common: St. Johns R.C. Church Historic: same
- 2. TOWN/CITY: Middletown VILLAGE: \_\_\_\_\_ COUNTY: Middlesex
- 3. STREET & NUMBER (and/or location): 9 St. John's Square
- 4. OWNER(S): Diocese of Norwich PUBLIC PRIVATE
- 5. USE: Present: Church Historic: same
- 6. ACCESSIBILITY TO PUBLIC: Exterior visible from public road: x yes no  
Interior accessible: x yes, explain religious services no

St. Johns R.C. Church  
9 St. John's Square, Middletown, Ct. 06457

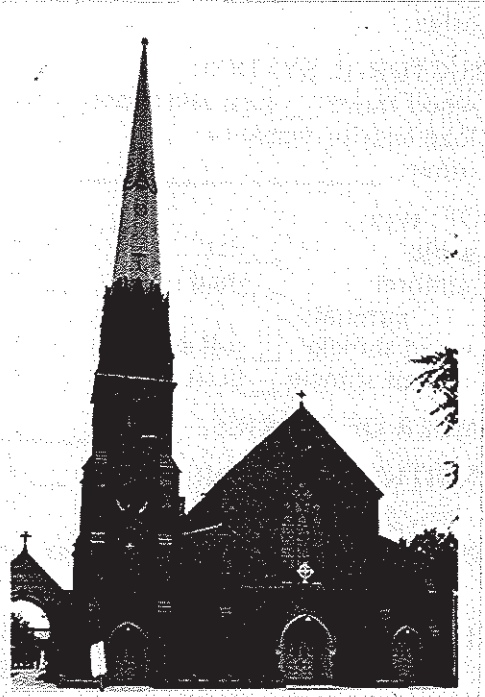
photographer: Roger Sherman  
 date: 10/78 view: south  
 negative on file: Roll 43, #2

The present sanctuary is constructed of roughly squared brownstone laid in a random-coursed ashlar pattern. The building is done in the ecclesiastic Gothic Revival style. The 1852 completion date makes it the earliest building of this style in Middletown.

Exterior features include compound Gothic arches over doors and windows, a cut brownstone water-table, and buttresses strengthening the outer walls. A nearly freestanding tower at the southwest corner supports a tall, slate-roofed spire.
