HISTORIC RESOURCES INVENTORY FORM  
For Buildings and Structures

- 1. BUILDING NAME: Common: \_\_\_\_\_ Historic: Aaron Pease House
- 2. TOWN/CITY: Middletown VILLAGE: \_\_\_\_\_ COUNTY: Middlesex
- 3. STREET & NUMBER (and/or location): 116 Washington Street
- 4. OWNER(S): Walter D. Briggs, Trustee PUBLIC  PRIVATE
- 5. USE: Present: Residence Historic: same
- 6. ACCESSIBILITY TO PUBLIC: Exterior visible from public road:  yes  no  
Interior accessible:  yes, explain with occupants permission  no

Aaron Pease House  
116 Washington Street, Middletown, CT 06457

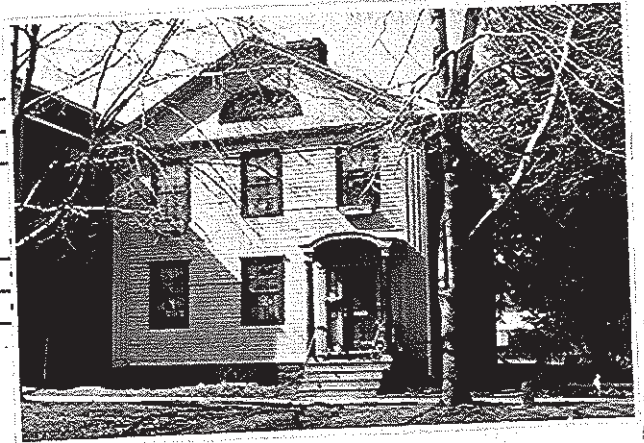
photographer: Robert Svec  
 date: 5/78 view: south  
 negative on file: Roll 20, #7

- 11. NUMBER OF STORIES: 2 1/2 APPROXIMATE DIMENSIONS: 22'x34'; north wing 21'x17'
- 12. CONDITION: Structural: \_\_\_ excellent  good \_\_\_ fair \_\_\_ deteriorated  
 Exterior: \_\_\_ excellent  good \_\_\_ fair \_\_\_ deteriorated

- 16. INTERRELATIONSHIP OF BUILDING AND SURROUNDINGS: This house faces south from the north side of Washington Street west of Main Street. Washington Street (Route 66) displays in this area some fine old residences with interspersed commercial buildings. This well-kept structure is tucked away behind large shade trees on Washington Street. A fenced yard opens out in the rear of the property. 216

- Leaded fanlight in flushboarded pediment
- Full height corner pilasters
- Denticulated cornice
- Entrance with fanlight and sidelights
