HISTORIC RESOURCES INVENTORY FORM  
For Buildings and Structures

- 1. BUILDING NAME: Common: \_\_\_\_\_ Historic: Chadwick Stone House
- 2. TOWN/CITY: Middletown VILLAGE: \_\_\_\_\_ COUNTY: Middlesex
- 3. STREET & NUMBER (and/or location): 11-13 Wetmore Place
- 4. OWNER(S): Cornelius V. Jay PUBLIC  PRIVATE
- 5. USE: Present: Double Residence Historic: same
- 6. ACCESSIBILITY TO PUBLIC: Exterior visible from public road:  yes  no  
Interior accessible:  yes, explain with permission  no

Chadwick Stone House  
11-13 Wetmore Place, Middletown, CT 06457

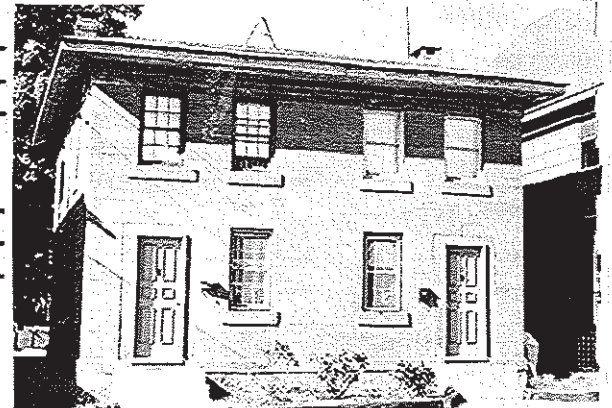
photographer: Elizabeth Loomis  
date: 10/78 view: north  
negative on file: Roll 40, #13-13A

This simple, dignified house, with the wide overhanging eaves of Italianate flavor, displays few stylistic features. The use of brownstone in an unpretentious residence is rare in Middletown. The house is also unusual as a remnant of early "builder's development," one of Henry Fountain's first ventures of this type in Middletown.
